PIC16(L)F1938/1939 Silicon Errata and Data Sheet Clarification

The PIC16(L)F1938/1939 family devices that you have received conform functionally to the current Device Data Sheet (DS40001574C), except for the anomalies described in this document.

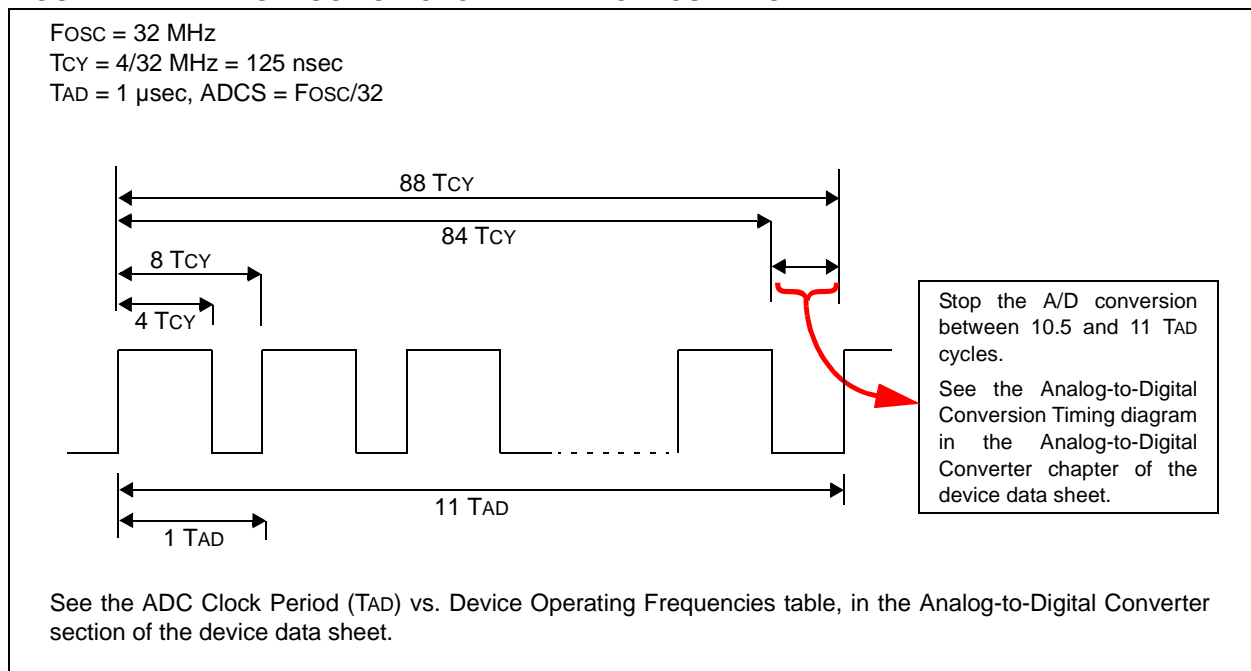
FIGURE 1: INSTRUCTION CYCLE DELAY CALCULATION EXAMPLE

An ADC conversion may not complete under these conditions:

1. When FOSC is greater than 8 MHz and it is the clock source used for the ADC converter.
2. The ADC is operating from its dedicated internal FRC oscillator and the device is not in Sleep mode (any FOSC frequency).

When this occurs, the ADC Interrupt Flag (ADIF) does not get set, the GO/DONE bit does not get cleared, and the conversion result does not get loaded into the ADRESH and ADRESL result registers.

In Figure 1, 88 instruction cycles (Tcy) will be required to complete the full conversion. Each TAD cycle consists of 8 Tcy periods. A fixed delay is provided to stop the A/D conversion after 86 instruction cycles and terminate the conversion at the correct time as shown in the figure above.

Note: The exact delay time will depend on the TAD divisor (ADCS) selection. The Tcy counts shown in the timing diagram above apply to this example only. Refer to Table 3 for the required delay counts for other configurations.

Method 3: This method is provided if the application cannot use Sleep mode and requires continuous operation at frequencies above 8 MHz. This method requires early termination of an ADC conversion. Provide a fixed time delay in software to stop the A-to-D conversion manually, after all 10 bits are converted, but before the conversion would complete automatically. The conversion is stopped by clearing the GO/DONE bit in software. The GO/DONE bit must be cleared during the last 1/2 TAD cycle, before the conversion would have completed automatically. Refer to [Figure 1](#) for details.

```
BSF    ADCON0, ADGO    ; Start ADC conversion
                        ; Provide 86
                        ; instruction cycle
                        ; delay here
BCF    ADCON0, ADGO    ; Terminate the
                        ; conversion manually
MOVF   ADRESH, W       ; Read conversion
                        ; result
```

TAD	Instruction Cycle Delay Counts
Fosc/64	172
Fosc/32	86
Fosc/16	43
