Mobile Intel[®] Pentium[®] 4 Processor-M

Specification Update

September 2004

Document Number: [250721-025](#)

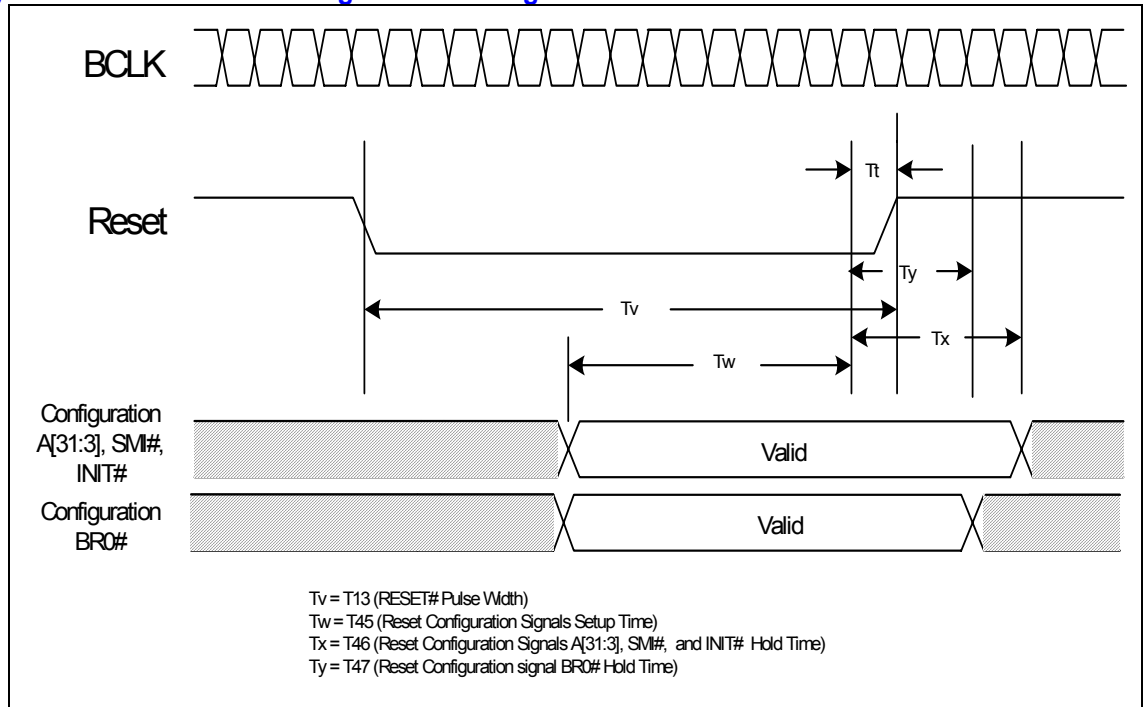
Figure 13. System Bus Reset and Configuration Timings

The BR0# maximum hold time has changed to 2 BCLKs. This change will be shown in the “System Bus AC Specifications (Reset Conditions)” table and “System Bus Reset and Configuration Timings” figure of the *Mobile Intel® Pentium® 4 Processor - M Datasheet*. This change will be incorporated in the next revision of the datasheet.
